Lessons Learned From Commercial Kitchen Fire Investigations

BY DOUG HORTON

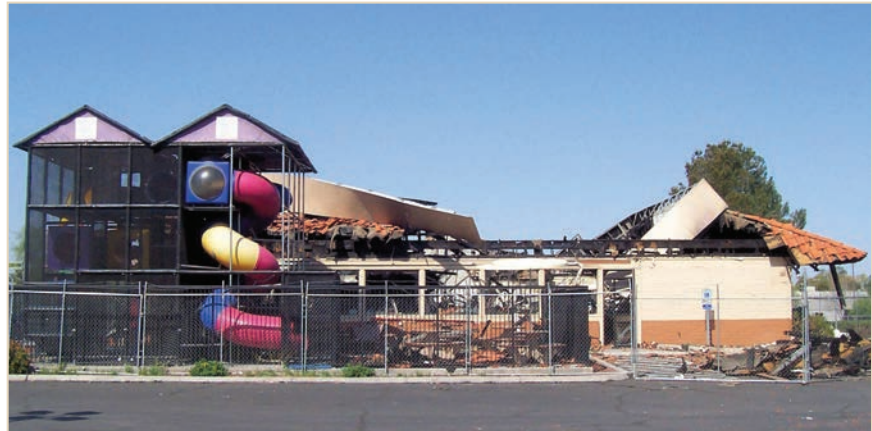
Total loss of quick service restaurant and play area. A large amount of burnt grease was found inside the backs

of three fryers, suggesting ignition from the gas burner flues. Although the fire suppression system activated, fire spread throughout the building, which totally collapsed as shown in *Photo 1*. Investigators noted that the kitchen equipment installation did not meet code and standards requirements for clearance to wood construction behind the appliances and exhaust hood, likely contributing to the spread of fire.

PHOTO 1 Total loss fire damage at quick service restaurant.

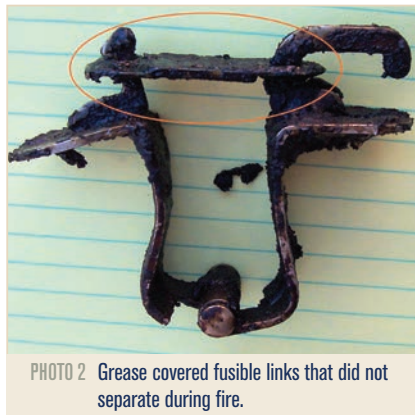
Total loss of quick service restaurant. Fire started in fryers under a low profile hood. The fire suppression system did not activate automatically, likely because fusible links were coated with hardened, decomposed grease, as shown in *Photo 2*, nor was the system manually activated by workers. Fire escaped the hood through a 4 in. by 12 in. (100 mm by 300 mm) rectangular hole inappropriately cut into the rear top of the hood for passage of electric conduits for fryer cooking timers. Fire spread to the void space between the duct and surrounding fascia metal, and because of inappropriate sealing of the duct at the ceiling, fire spread to the attic and roof, where wood construction burned and two-thirds of the building collapsed.

PHOTO 2 Grease covered fusible links that did not separate during fire.

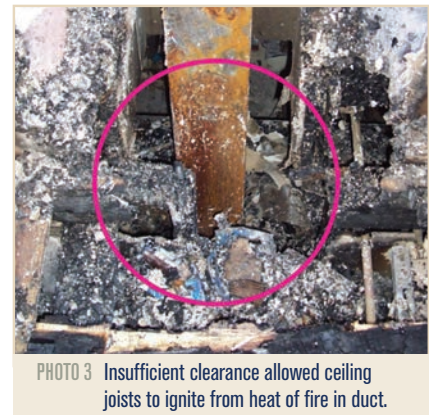
two kitchens, the manual pull station was in the back kitchen. Firefighters extinguished the fire under the fryer hood and left the scene after posting a fire watch outside. Flames were later seen burning through the second story roof. Investigators concluded that after firefighters left the first time, fire continued to burn in the fryer hood duct and ignited wood ceiling joists that were only 3 in. to 4 in. (75 mm to 100 mm) from the duct, with insufficient clearance, as shown in *Photo 3*. Although firefighters returned to fight the fire, the entire two story structure was destroyed.

PHOTO 3 Insufficient clearance allowed ceiling joists to ignite from heat of fire in duct.

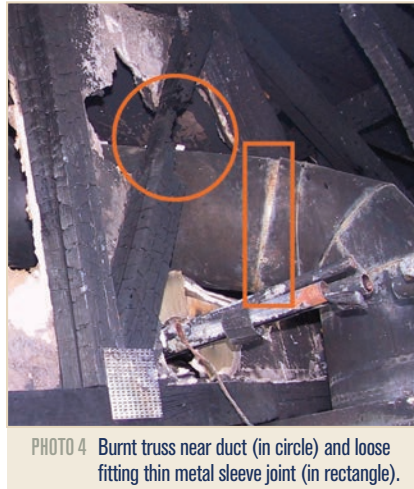
Fire spread was aided by two issues related to the fryer exhaust duct, as shown in *Photo 4*.

- From a previous remodel, the fully welded steel duct was cut and extended with a section of thin galvanized vent piping, with loose fitting sleeve connections that allowed fire to escape from the duct into the attic; and
- There was insufficient clearance from the duct to wood trusses in the attic.

PHOTO 4 Burnt truss near duct (in circle) and loose fitting thin metal sleeve joint (in rectangle).

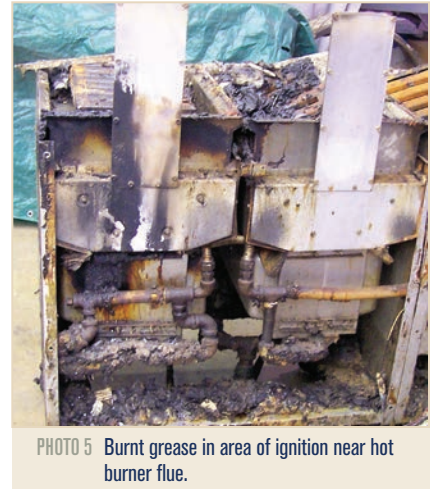
Total loss of quick service restaurant in remodeled historic building. Fire started in the rear of a set of fryers. The fire was caused by an accumulation of grease inside the fryers near the hot gas burner flues, as shown in *Photo 5*. Some of the grease sprayed toward the flue area from a cooking oil leak in plastic piping added with the installation of a third-party cooking oil disposal and replenishment system. The fire system activated but did not prevent fire spread and loss of the entire historic building.

PHOTO 5 Burnt grease in area of ignition near hot burner flue.
