Factors of Fire Ignition and Spread – A Multi-Restaurant Case Study

TB20-1015

March 20th, 2020

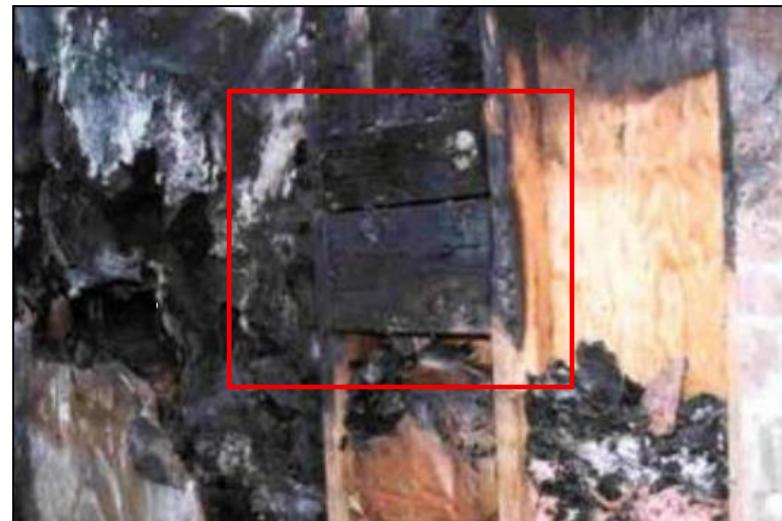
Further inspections after the fires pointed to the fires starting in or around closed wood cavities behind the cheese melters. The questions the report strove to answer were: how and why?

Figure 1. Origin area in the wall behind the cheese melter with the appliance removed.

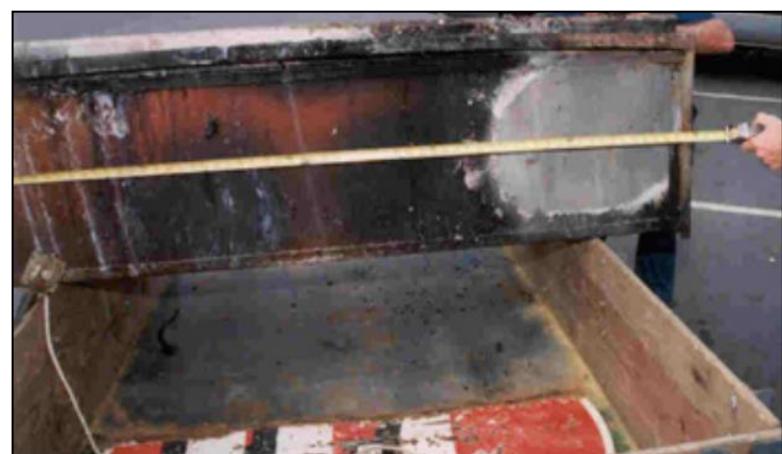
Figure 2. View of the back of the cheese melter with heat pattern on the right corresponding to the origin area on wall.

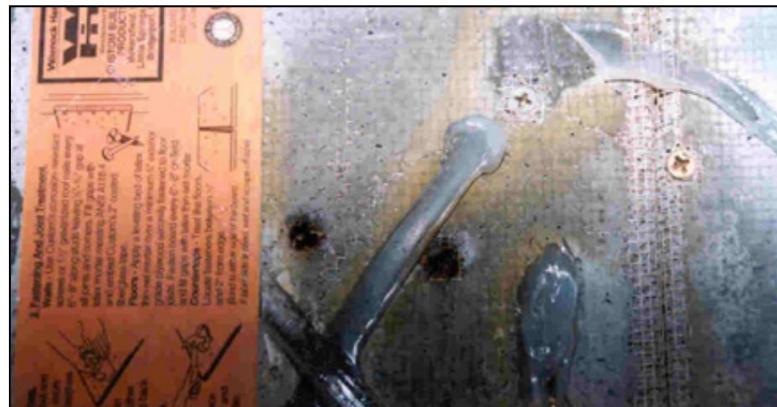
With three similar fires, and major damage to two of the restaurants, similar closed cavities behind the cheese melters were checked in three other of the chain's restaurants that had not experienced fires. Investigators removed the cheese melters and other materials, including portions of the stainless steel backsplashes, to access the closed cavities behind the cheese melters. These observations revealed charring on cement board, drywall and wood blocking in several locations in the closed cavities, especially near lag bolts that penetrated from the cheese melter hanging brackets to the closed cavities. See Figure 3-5.

Figure 3. Heat damage on Durock[®] cementboard covering the wood blocking where the cheese melter hung

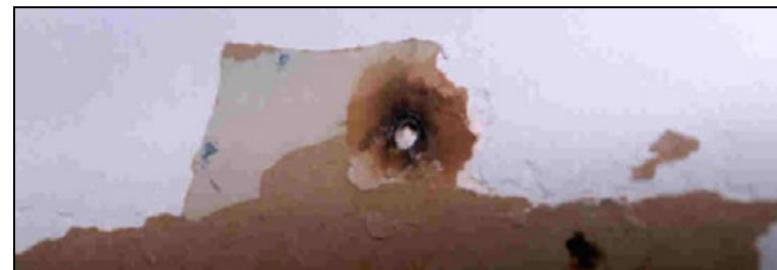
Figure 4. Heat damage on drywall covering the wood blocking where the cheese melter hung.

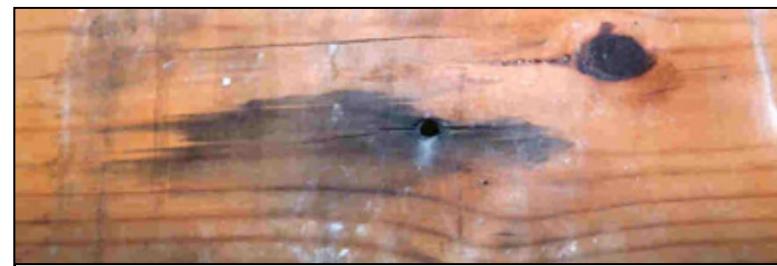
1. "The only competent ignition source...was excessive conduction heat transfer into the horizontal wood blocking...through the lag bolts."
2. Combined laboratory and manufacturer testing "demonstrate that low temperature ignition of wood clearly occurs."

Figure 5. Heat damage on wood blocking.
